**Atacama
Large
Millimeter
Array**

H-MASER Installation Workmanship Inspection Report

ALMA-05.11.21.90-0001-A-REP

2014-08-14

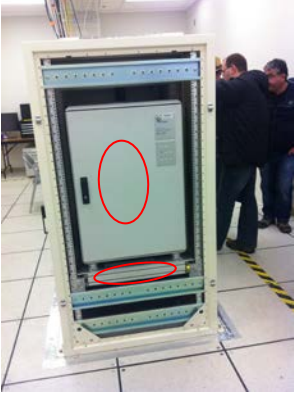
No labels to indicate the correct operation of the MASER Support structure	D	open
2

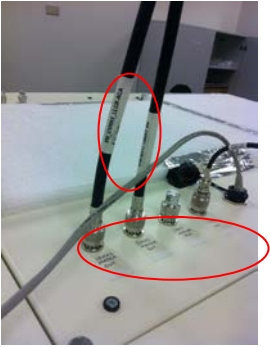
Rack and Cable labeling needs to be corrected	D	open
3

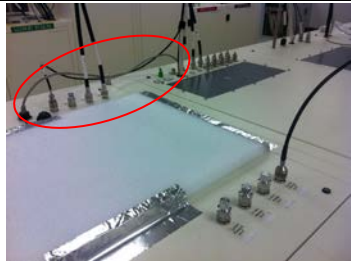
Ethernet MASER connection needs to be rerouted	D	open
