Problem with 160 MHz mode

Bad (oscillating?) tiles in HBA 5 mode on startup in local mode:

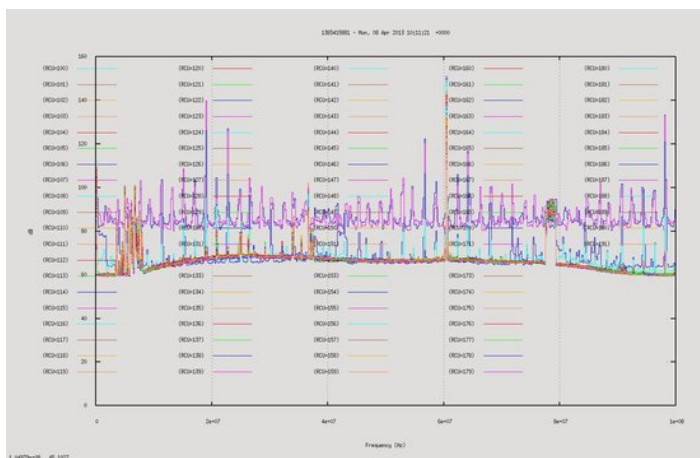
RCUs 18,19,34 are very bad

RCUs 50,51,52 are modestly bad (high ringing around line at 161 MHz)

Tiles 9,17 are very bad

Tiles 25, 26 are modestly bad

When the bad tiles are in, the spectra from RCUs look like

Set pulsar RCU command to 0:17,20:33,36:49,54:81,84:191

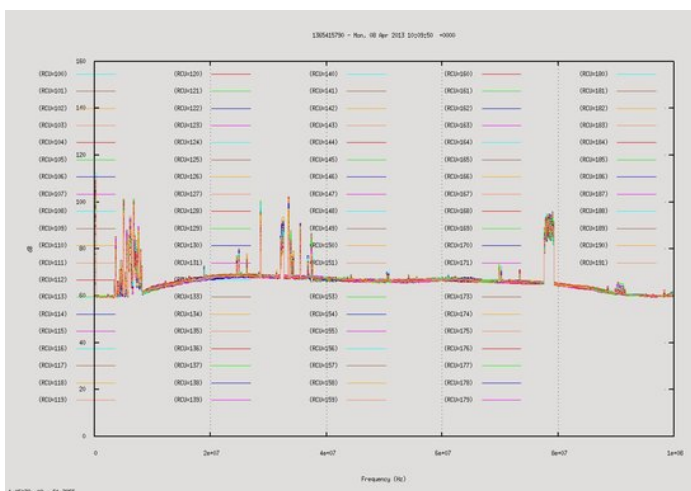
With those tiles turned off, there is no more 161 MHz line.

and when they are not powered up, the spectra of the

remaining RCUs look like
