2013 June 4

Report from Henri Muelman at ASTRON

2013 June 25

1st day of maintenance visit

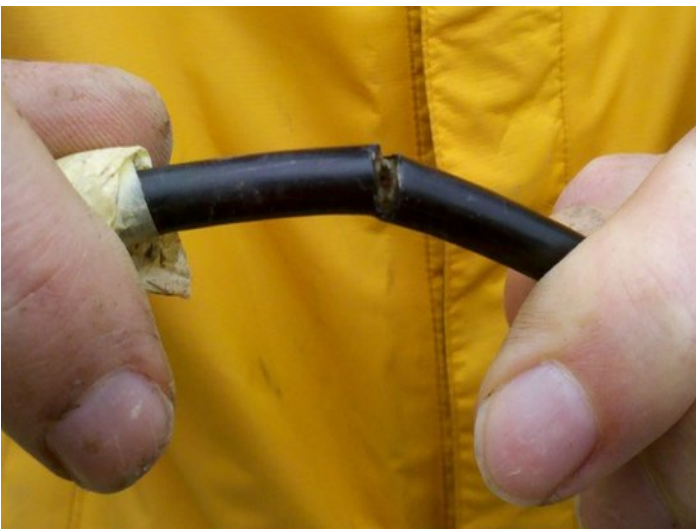
Both cables to LBA 34 (RCUs 68/69) were cut into, on the X-cable the cut went all the way to the central core (see left image below). The X-cable showed corrosion on the central core and the shielding, we cut that cable at a place still below the antenna where there was still some corrosion and installed a temporary replacement. The Y-cable did not show corrosion on the central core, but did show heavy corrosion on the shielding, so that the first tries to attach a working connector were unsuccessful. We had to cut away several meters of cable to get to a part where the corrosion was reduced enough so that we could install a working connector for a temporary replacement (see right image below).

- tightened several connectors in HBA tiles (among others in tile 9 (RCUs 18/19), element 15)
- removed corrosion from several connectors in HBA tiles (among others: tile 9 (RCUs 18/19), element 16)
- taped up LBA cables to prevent (more) water from getting into the cables: RCUs 150/151 (LBA 75), RCUs 108/109 (LBA 54)
- replaced some LBA heads (among others, RCUs 106/107 (LBA 53))
- replaced part of the cable to LBA 34, RCUs 68/69, see below:
