Clock synthesizer

Noise Generator

BDC

R2DBE installation

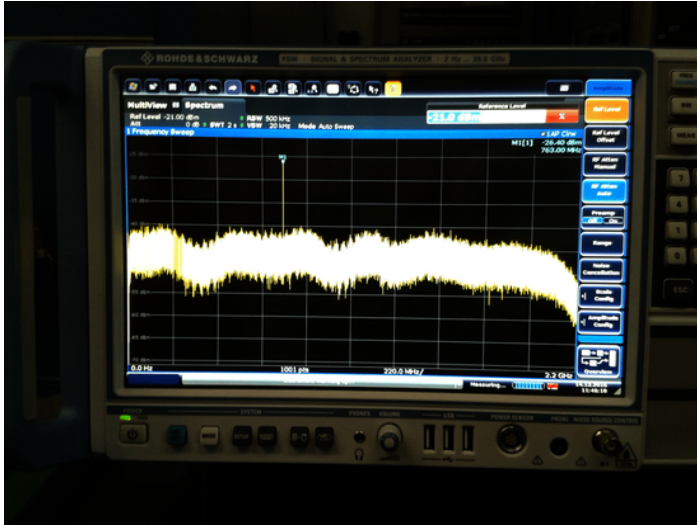
Injected a tone on the backside of the noise generator and inspected the output of all 4 outputs. The line was verified to be in the correct location in all 4 outputs. The power level of the noise signal was around -47dBm which corresponds to a total power over the 2GHz band of -9dBm.

Noise + injected tone as measured at one of the outputs of the noise generator unit. For the other three outputs the situation looks very similar.

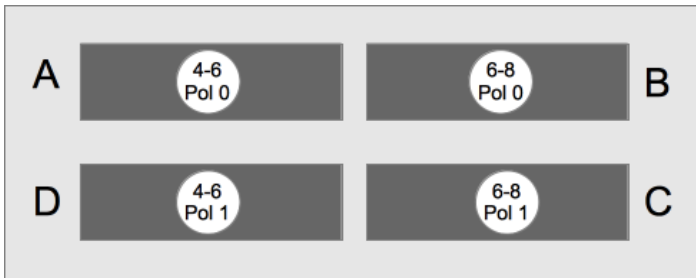
The 4 IF outputs of the BDC have been labeled and connected to the noise generator unit frontside panel.

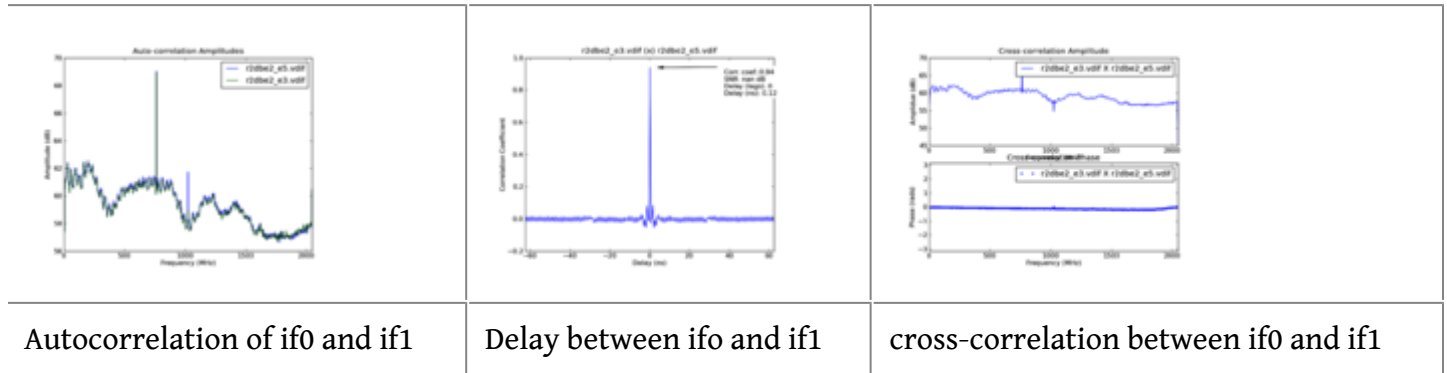
The line is recovered at the correct location in both IFs. Corr coefficient is 0.95.

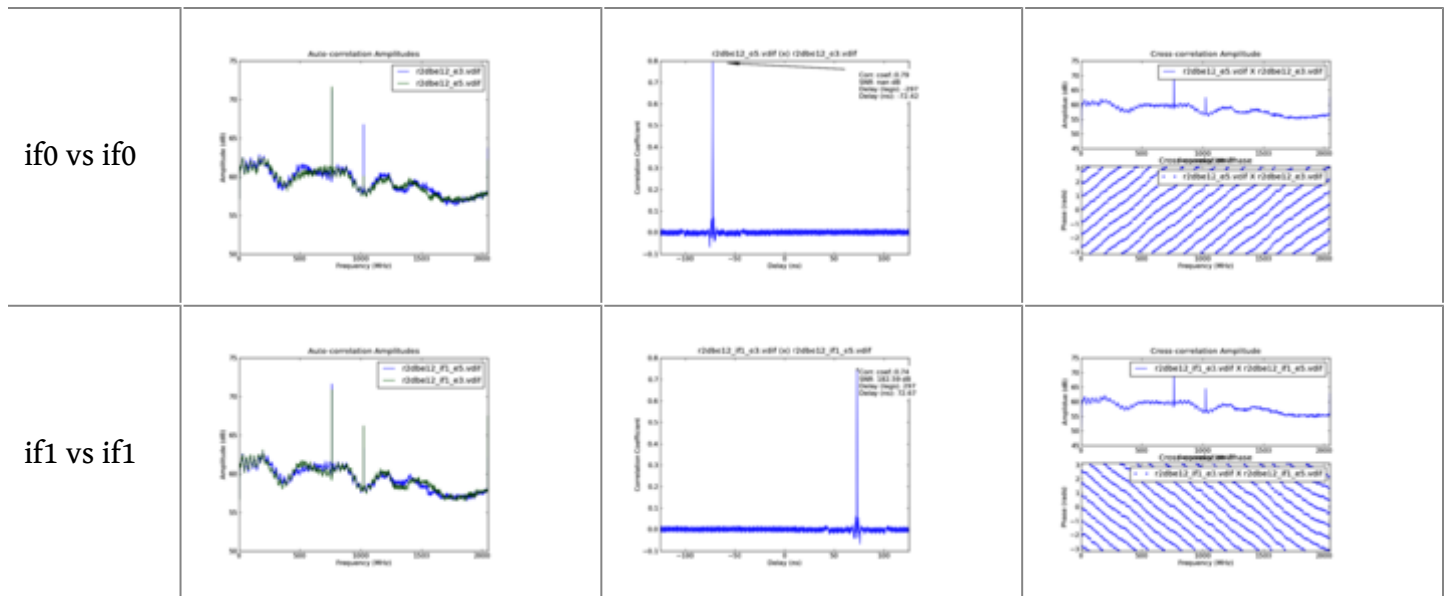
For cross-correlating between both R2DBEs the 10Gb cables entering the Mark6 recorder were swapped.

The correlation coefficient has dropped to about 0.79 and 0.74.
