## Clock synthesizer

## R2DBE installation

## R2DBE test

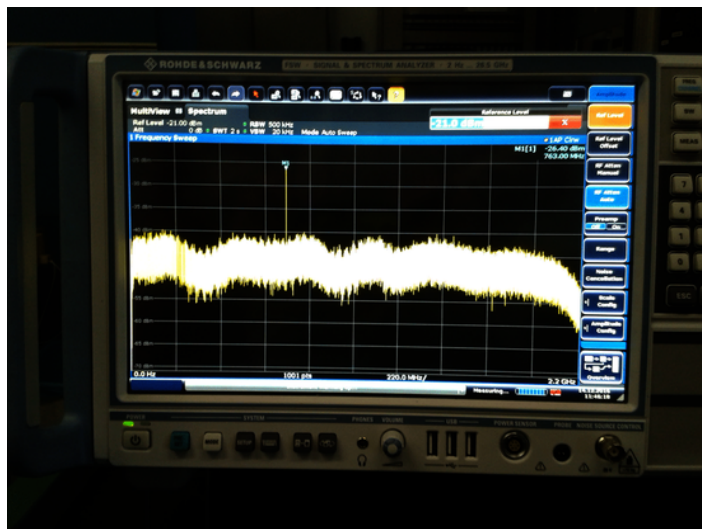
Injected a tone on the backside of the noise generator and inspected the output of all 4 outputs. The line was verified to be in the correct location in all 4 outputs. The power level of the noise signal was around -47dBm which corresponds to a total power over the 2GHz band of -9dBm.

Noise + injected tone as measured at one of the outputs of the noise generator unit. For the other three outputs the situation looks very similar.

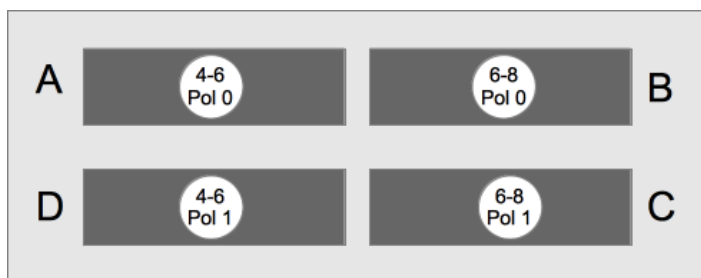
The 4 IF outputs of the BDC have been labeled and connected to the noise generator unit frontside panel.

**TODO: confirm the IF input power levels are meeting the specs once the IFs are connected to the telescope. According to the email by Ronald Hesper the input power level into the BDC should be around -33dBm (with no BDC attenuation). This should produce an output power of -7dBm which is the target for the R2DBE backends.**

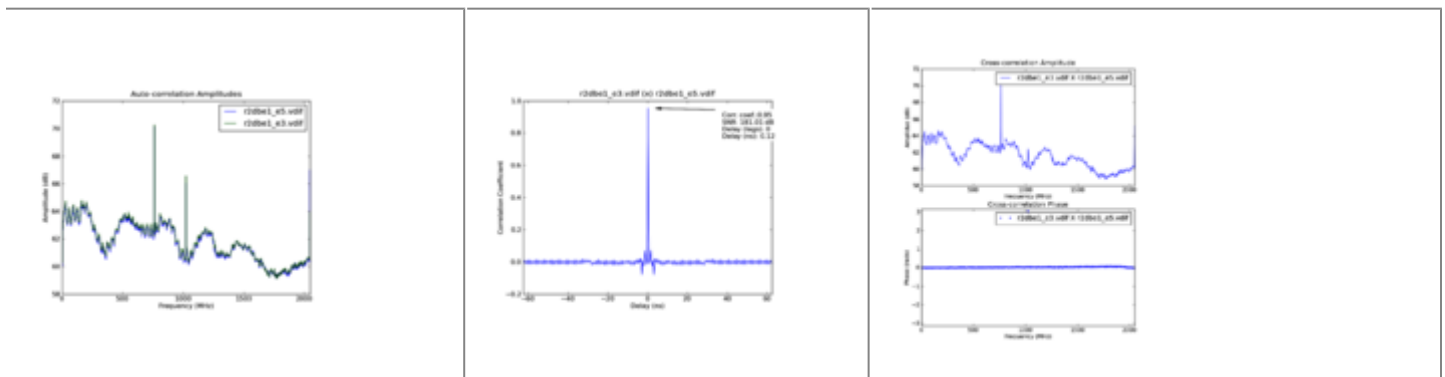
Autocorrelation of if0 and if1	Delay between if0 and if1	cross-correlation between if0 and if1
--------------------------------	---------------------------	---------------------------------------

The line is recovered at the correct location in both IFs. Corr coefficient is 0.95.

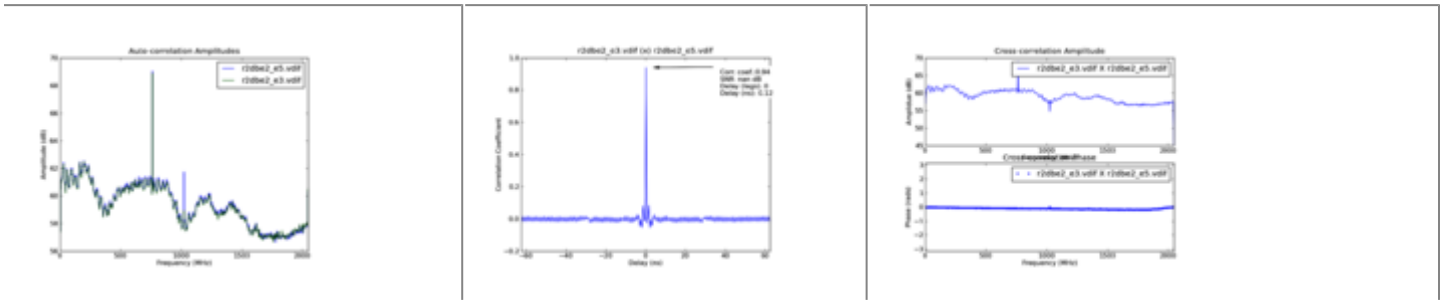
Autocorrelation of if0 and if1	Delay between if0 and if1	cross-correlation between if0 and if1
--------------------------------	---------------------------	---------------------------------------

The line is recovered at the correct location in both IFs. Corr coefficient is 0.95.

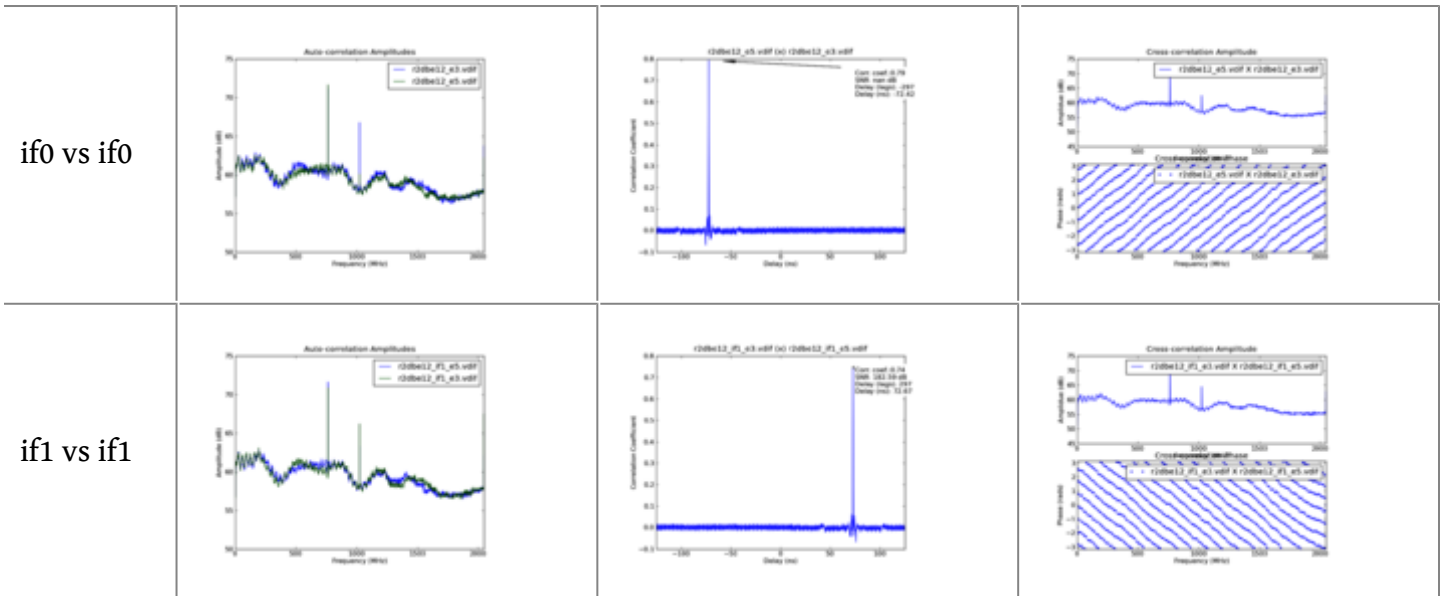
The correlation coefficient has dropped to about 0.79 and 0.74.
