Clock synthesizer

Noise Generator

BDC

R2DBE installation

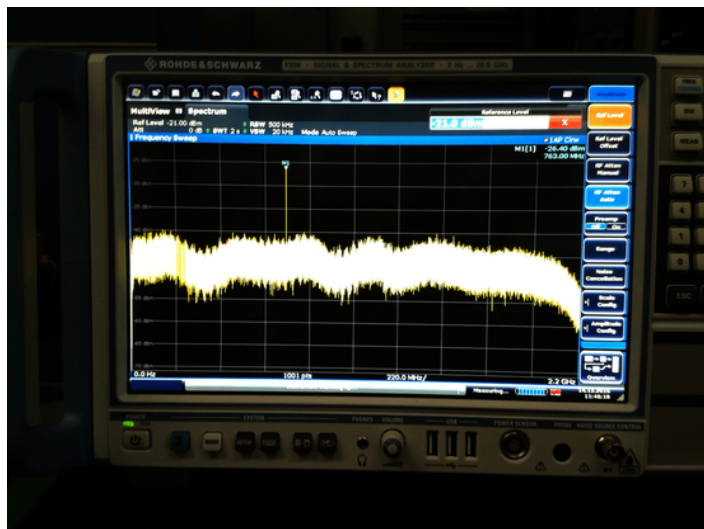
Injected a tone on the backside of the noise generator and inspected the output of all 4 outputs. The line was verified to be in the correct location in all 4 outputs. The power level of the noise signal was around -47dBm which corresponds to a total power over the 2GHz band of -9dBm.

Noise + injected tone as measured at one of the outputs of the noise generator unit. For the other three outputs the situation looks very similar.
