Clock synthesizer

Noise Generator

BDC

R2DBE installation

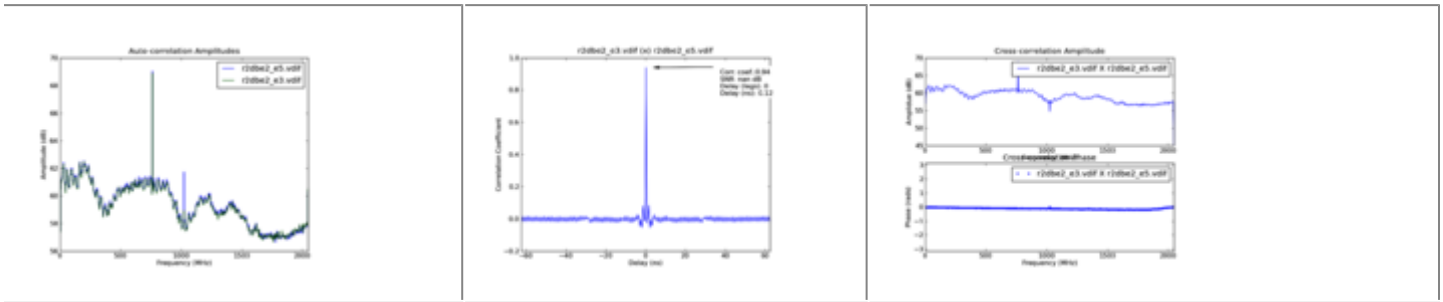
Autocorrelation of if0 and if1	Delay between if0 and if1	cross-correlation between if0 and if1
--------------------------------	---------------------------	---------------------------------------

The line is recovered at the correct location in both IFs. Corr coefficient is 0.95.
