Jan 2021

The DBBC3 has been returned from Bonn where it underwent a complete rehaul. The ADB3L and Core3H boards were replaced with the production version (v2). In addition the following components were redone: cabling, PC-board, FPGA heatsinks. The airvent grid has been removed in order to increase the airflow through the DBBC3.

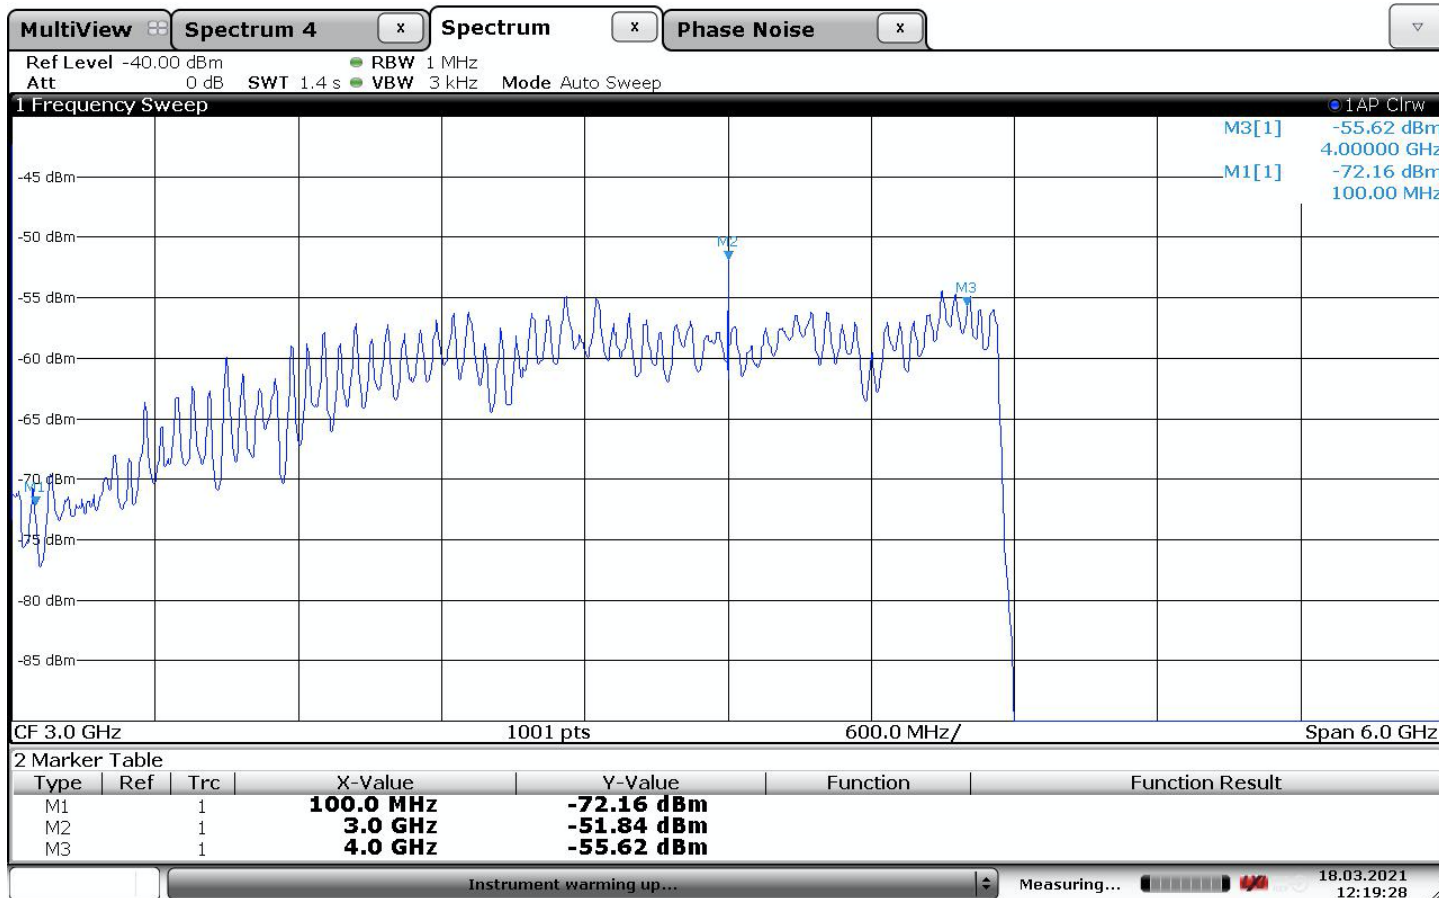
GComo

The output spectrum after the downconversion by the GComo:
