Jan 2021

The DBBC3 has been returned from Bonn where it underwent a complete rehaul. The ADB3L and Core3H boards were replaced with the production version (v2). In addition the following components were redone: cabling, PC-board, FPGA heatsinks. The airvent grid has been removed in order to increase the airflow through the DBBC3.

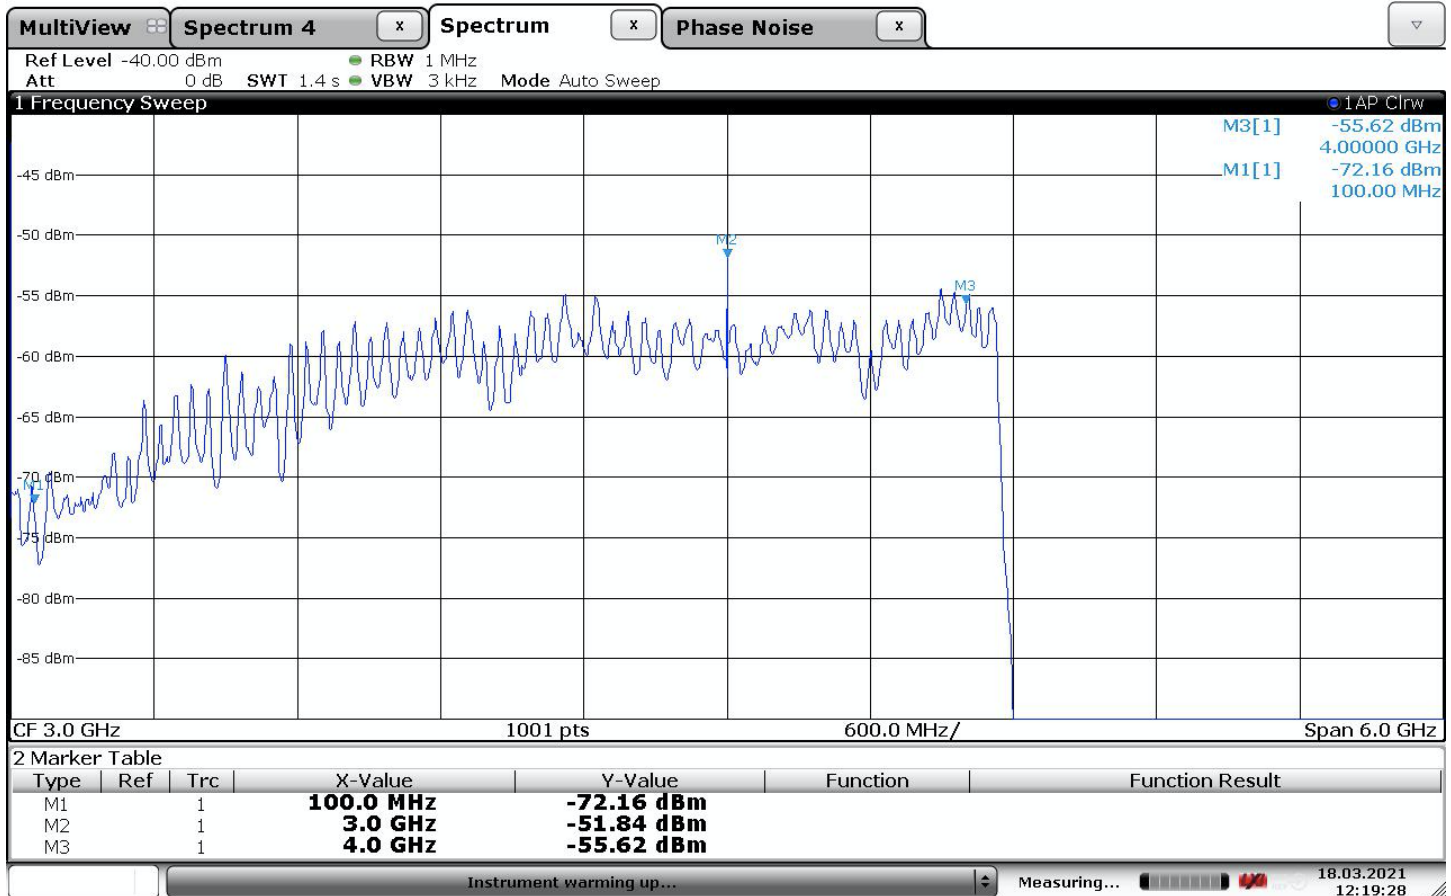
The output spectrum after the downconversion by the GComo:
