DBBC3 Testing for APEX and Pico Veleta

MPIfR / Istituto di Radioastronomia

DBBC3 EHT Design Review History

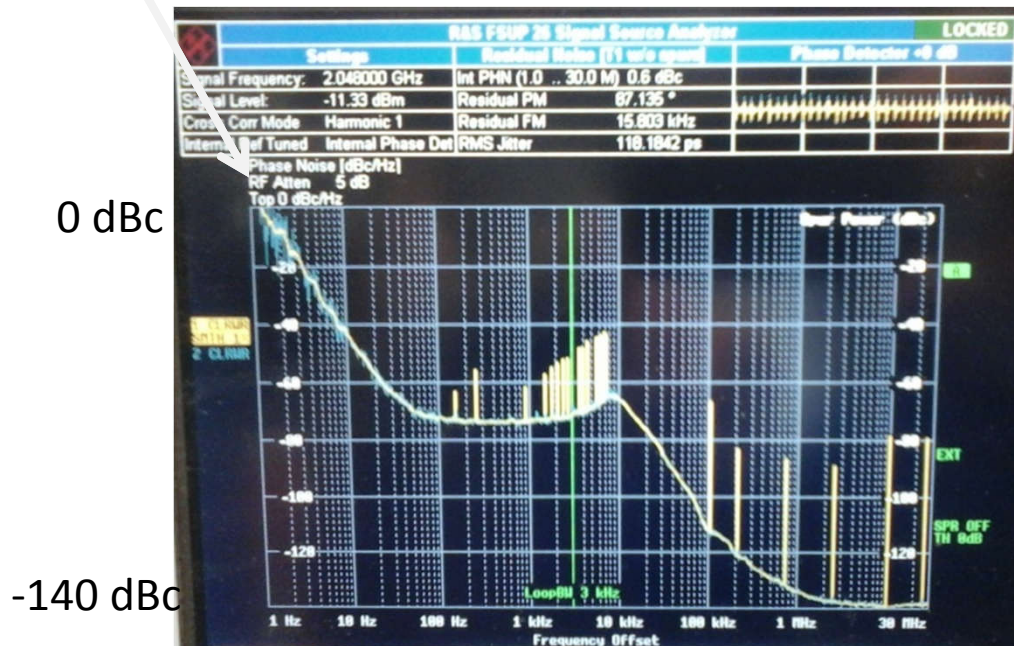
2048 MHz Clock using Lab 10 MHz Ref

Excess close-in PN

1 Hz 30 MHz

87° RMS random phase jitter(!!!)

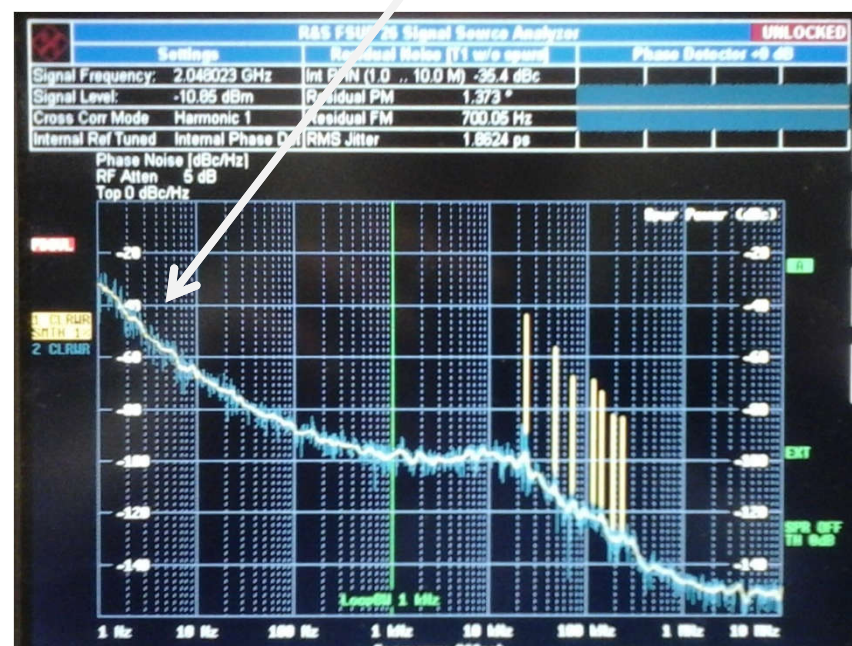
2048 MHz Clock using Wiltron 10 MHz Ref

Much less close-in PN

1 Hz 30 MHz

1.9° RMS random phase jitter

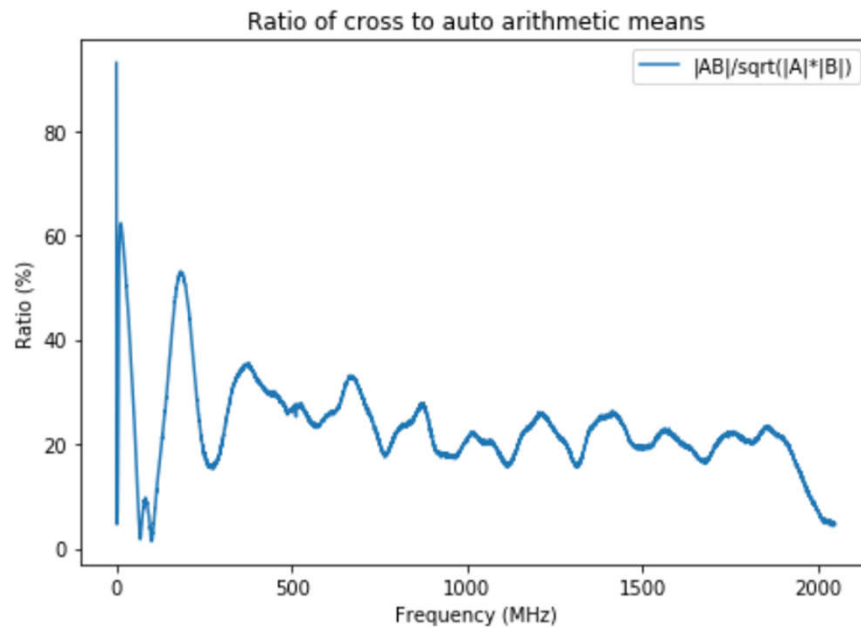
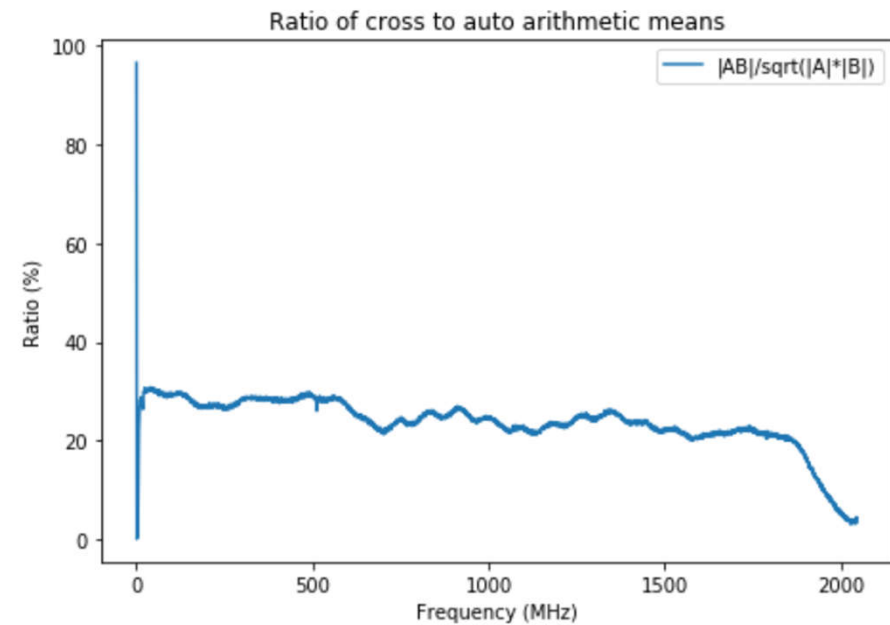
ORA#(35) Bandpass Ripple

2018 Sep

2018 Nov 05

- Improved component selection in analogue combiner

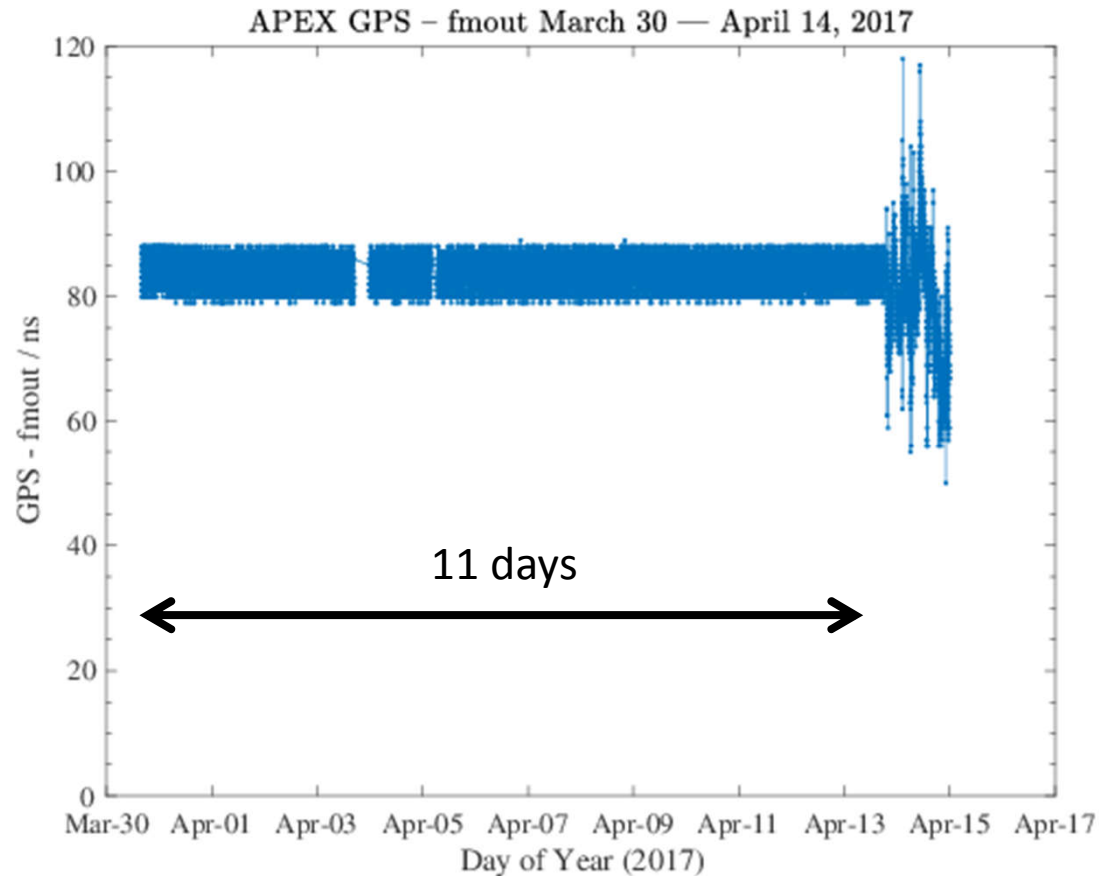
ORA#1 Too-Stable 1 PPS GPS-FMOUT

- Cause: firmware performs re-sync each second on 1 PPS input
- Fix: 2-line change in firmware, recompilation not stable (Xilinx ISE issue; need PlanAhead)

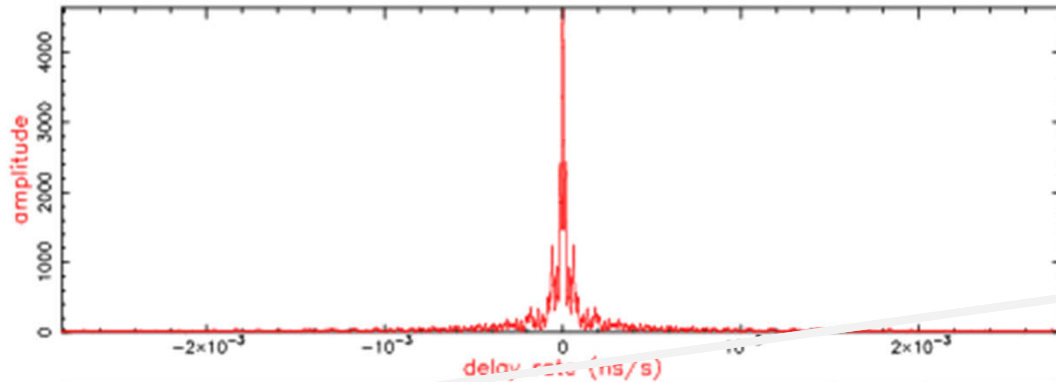
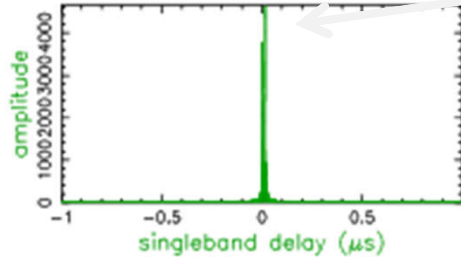
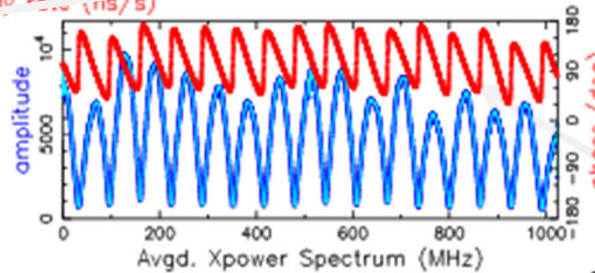
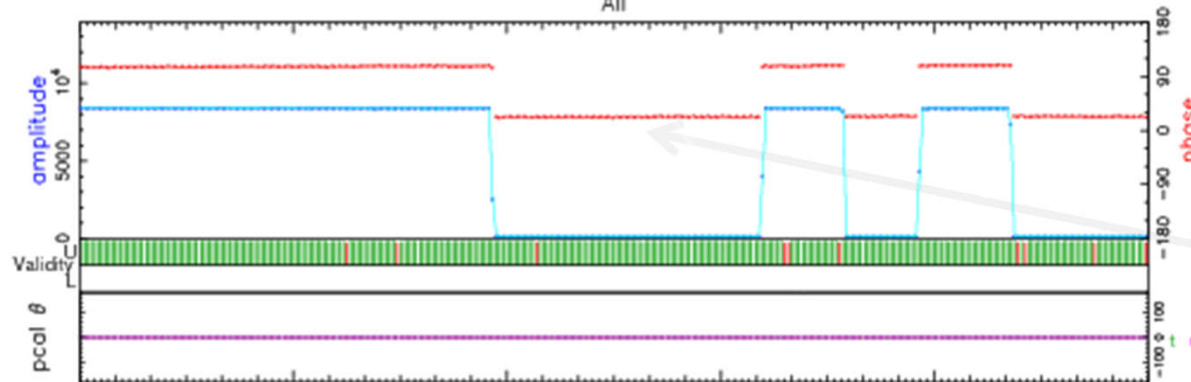
Fringe quality 5
Error code H
SNR 309442.6
Int time 297.475
Amp 4639.193
Phase 106.3
PFD 0.0e+00
Delays (us)
SBD 0.016408
MBD -0.000001
Fringe rate (Hz)
-0.000002
TEC 0.000
Ref freq (MHz)
347067.0000
AP (sec) 0.512
Exp. e18s21
Exper # 3669
Yr/day 2018:294
Start 092200.00
Stop 092700.03
FRT 092430.00
Corr/FF/build
2018:303:1 02620
2018:303:1 21417
2018:249:09 1612
RA & Dec (J2000)
04h23m15.800727s
-1°20'33.065552"

SBD twin peaks

16 cycles beating at 4096 MSps
-> 1/ 256 MHz delay slip
CORE3 clock = 256 MHz

Amp -> zero intermittently,
phase jump

Cause: Re-syncing on 1 PPS, firmware fixed, not yet stable
