# 3.4.2013

### Problem with 160 MHz mode

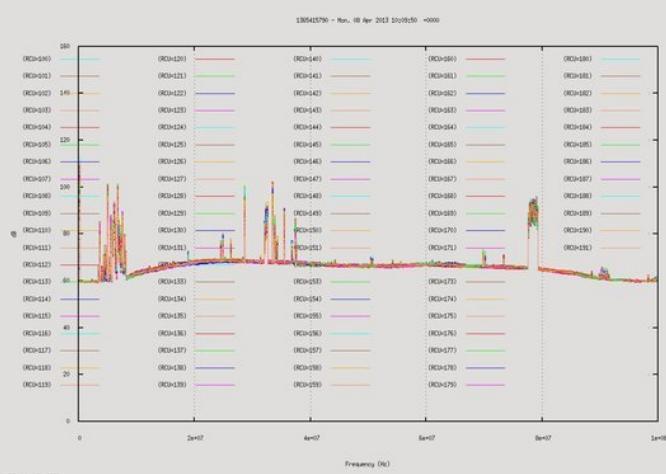
Bad (oscillating?) tiles in HBA 5 mode on startup in local mode: RCUs 18,19,34 are very bad

RCUs 50,51,52 are modestly bad (high ringing around line at 161 MHz)

With those tiles turned off, there is no more 161 MHz line.

## When the bad tiles are in, the spectra from RCUs look like

and when they are not powered up, the spectra of the

remaining RCUs look like

Set pulsar RCU command to 0:17,20:33,36:49,54:81,84:191
