DBBC3 Testing for APEX and Pico Veleta

MPIfR / Istituto di Radioastronomia

DBBC3 EHT Design Review History

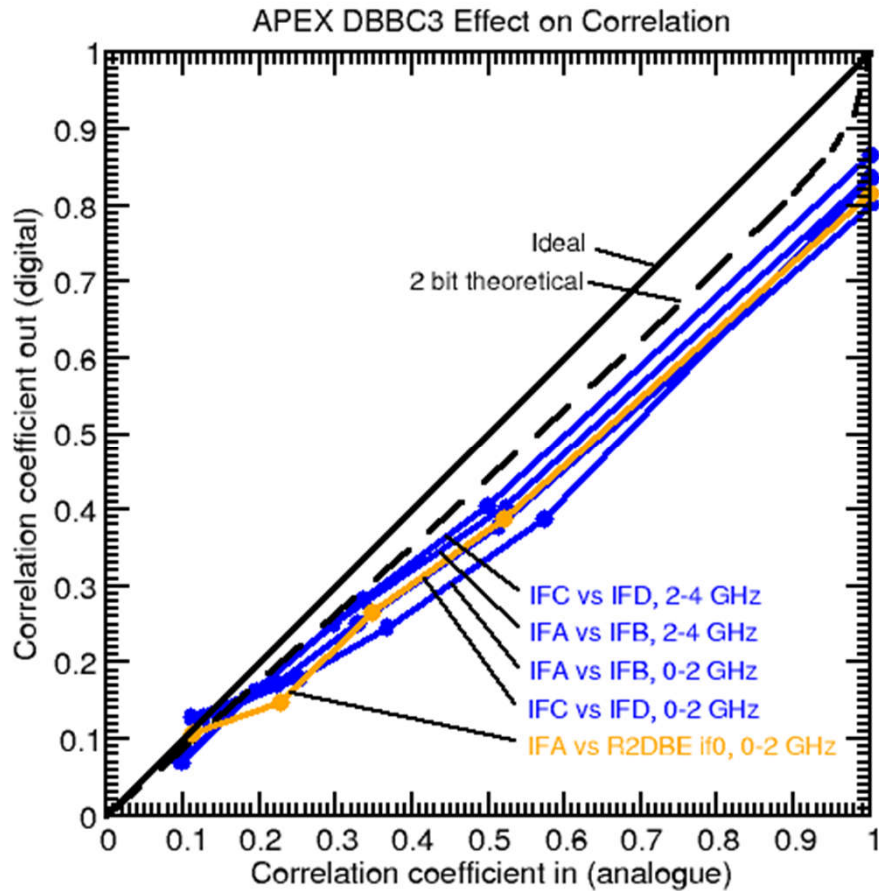
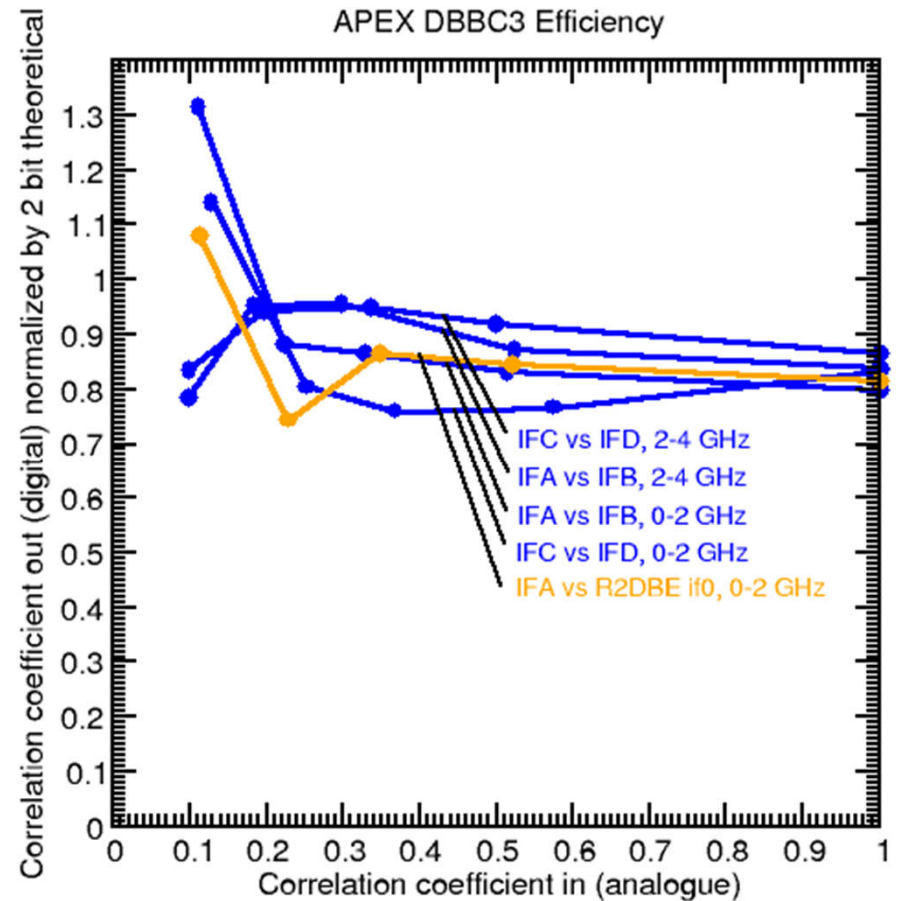
Zero Baseline Test: zerocorr analysis example for $\rho_0 = 0.336$

Efficiency of each backend: 90 % to 93 %

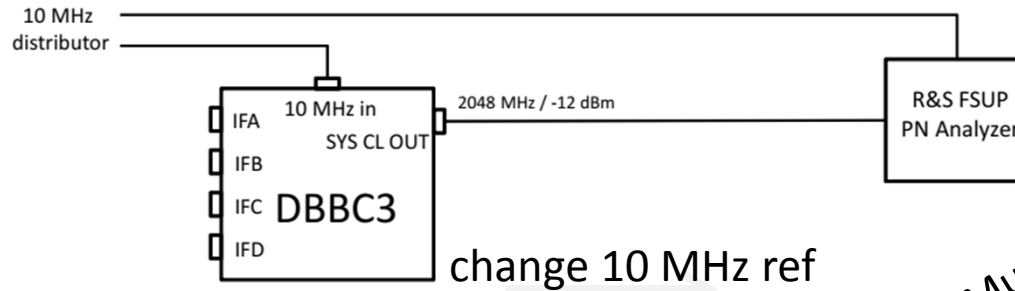
ORA#27 Timing Stability: Sampler Clock

Excess close-in PN

Much less close-in PN

2048 MHz Clock using Lab 10 MHz Ref

2048 MHz Clock using Wiltron 10 MHz Ref

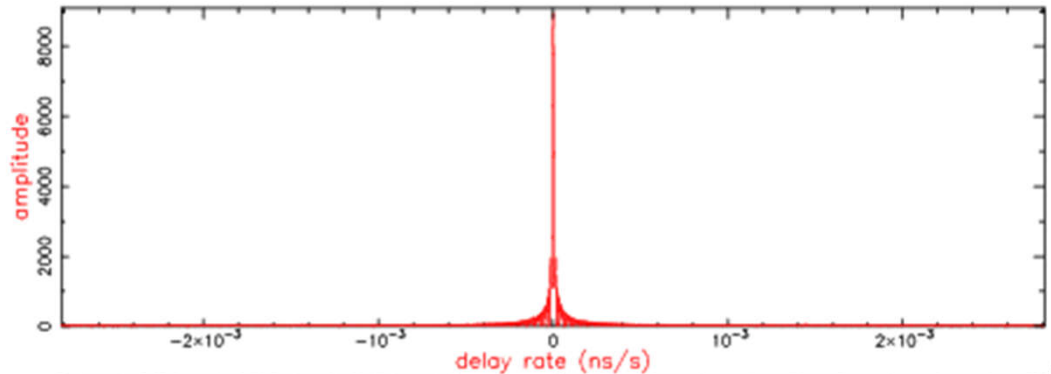
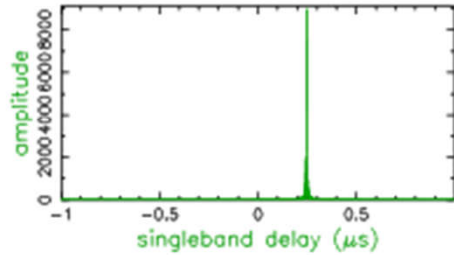
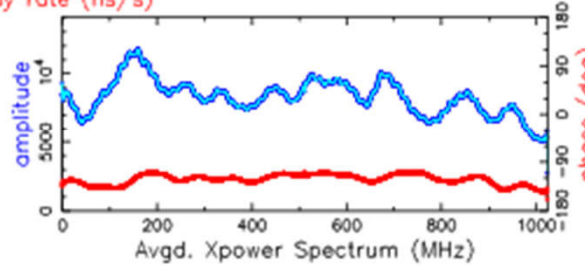
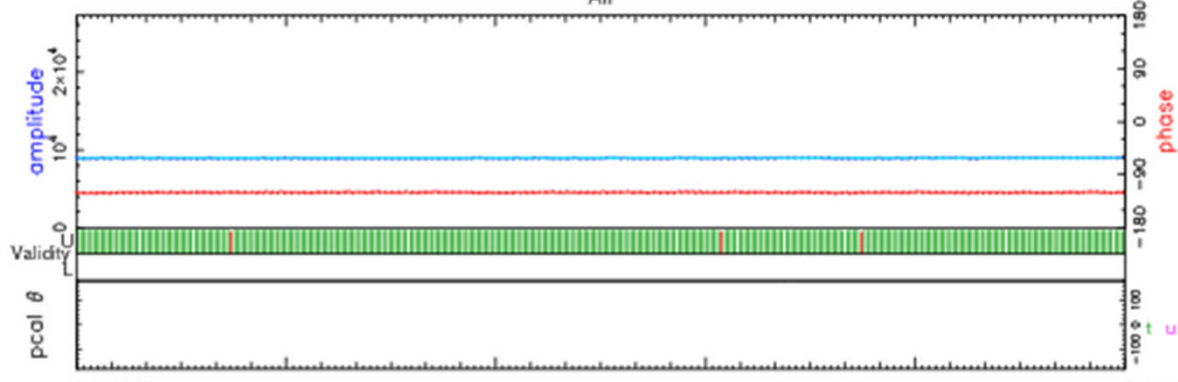
On-Sky Fringe Test EHT Oct 345 GHz

Fringe quality 9
Error code H
SNR 608341.6
Int time 299.187
Amp 9094.173
Phase -120.2
PFD 0.0e+00
Delays (us)
SBD 0.246486
MBD -0.000001
Fringe rate (Hz)
-0.000045
Ion TEC 0.000
Ref freq (MHz)
347067.0000
AP (sec) 0.512

Amp = 9094 whitneys
= 90.94 %
