**Atacama
Large
Millimeter
Array**

H-MASER Installation Workmanship Inspection Report

ALMA-05.11.21.90-0001-A-REP

2014-08-14

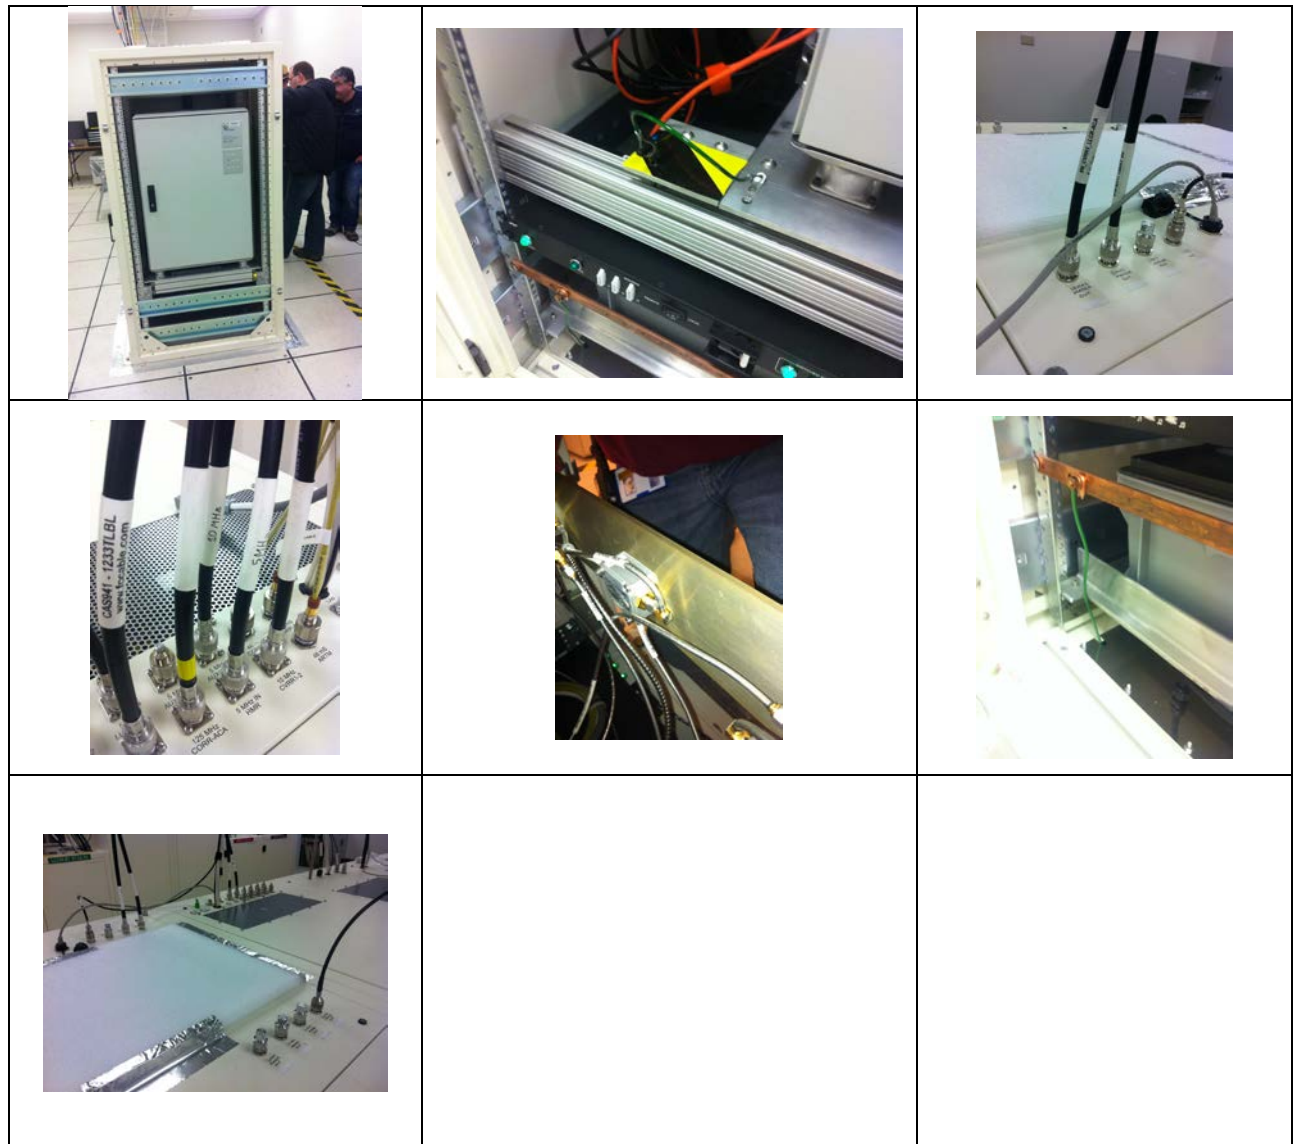
The H-MASER installation is mainly ok there are some minor issues mainly on labeling and cable routing, and also a substandard grounding strap that should be replaced.
