General

DBBC2

DBBC3

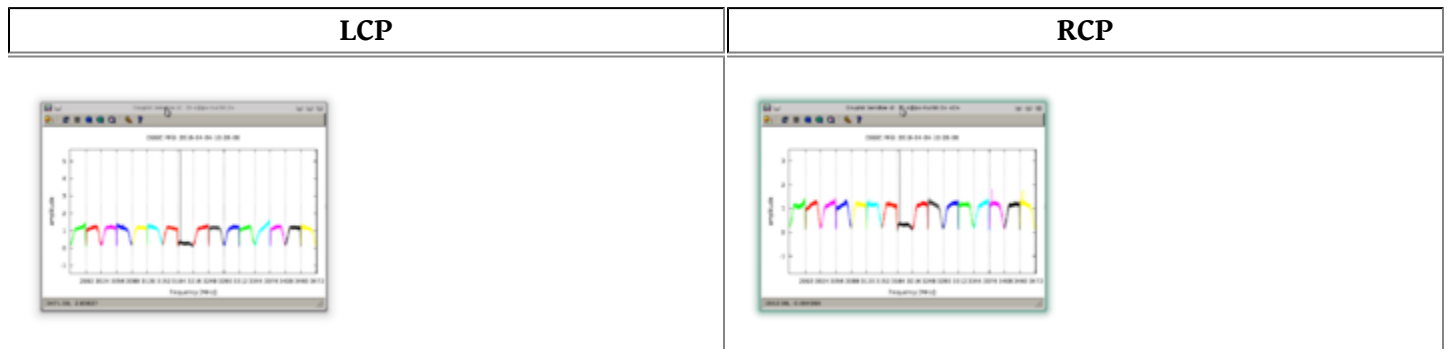
The recorded bistreams are in the following order:

BBC01_USB / BBC01_LSB / BBC02_USB / BBC02_LSB /
